Thermopile Support: FAQs, Troubleshooting, Care & Maintenance

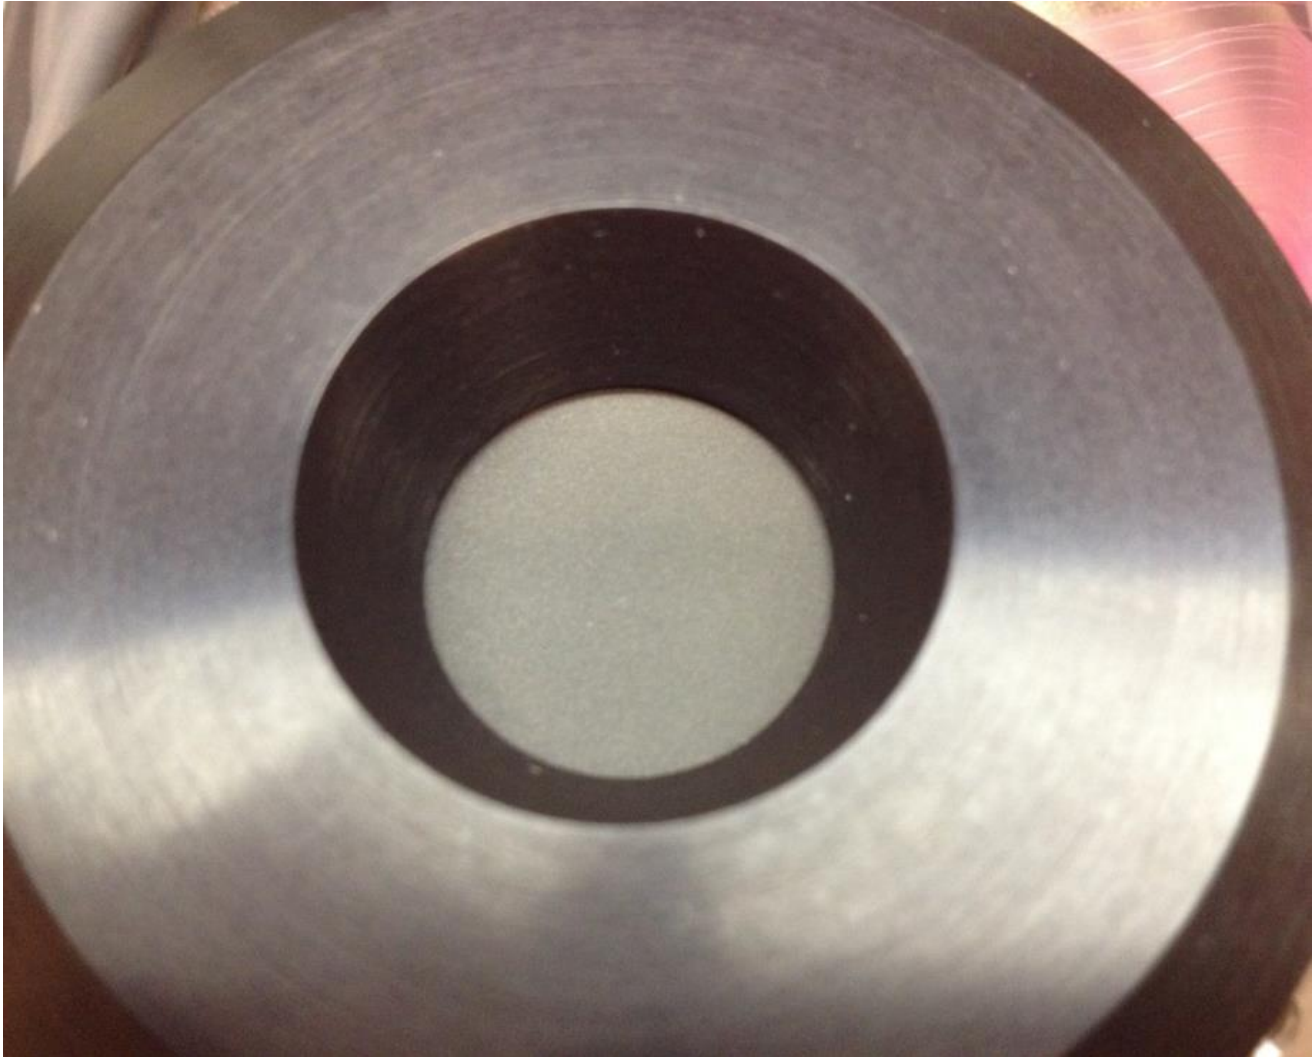
Figure 1: Healthy Thermopile Sensor with No Damage

The absorbing disk on the sensor is a uniform flat gray color with no discolorations or burn marks on it. A sensor in this condition will typically not have any problems with the thermopile disk itself.

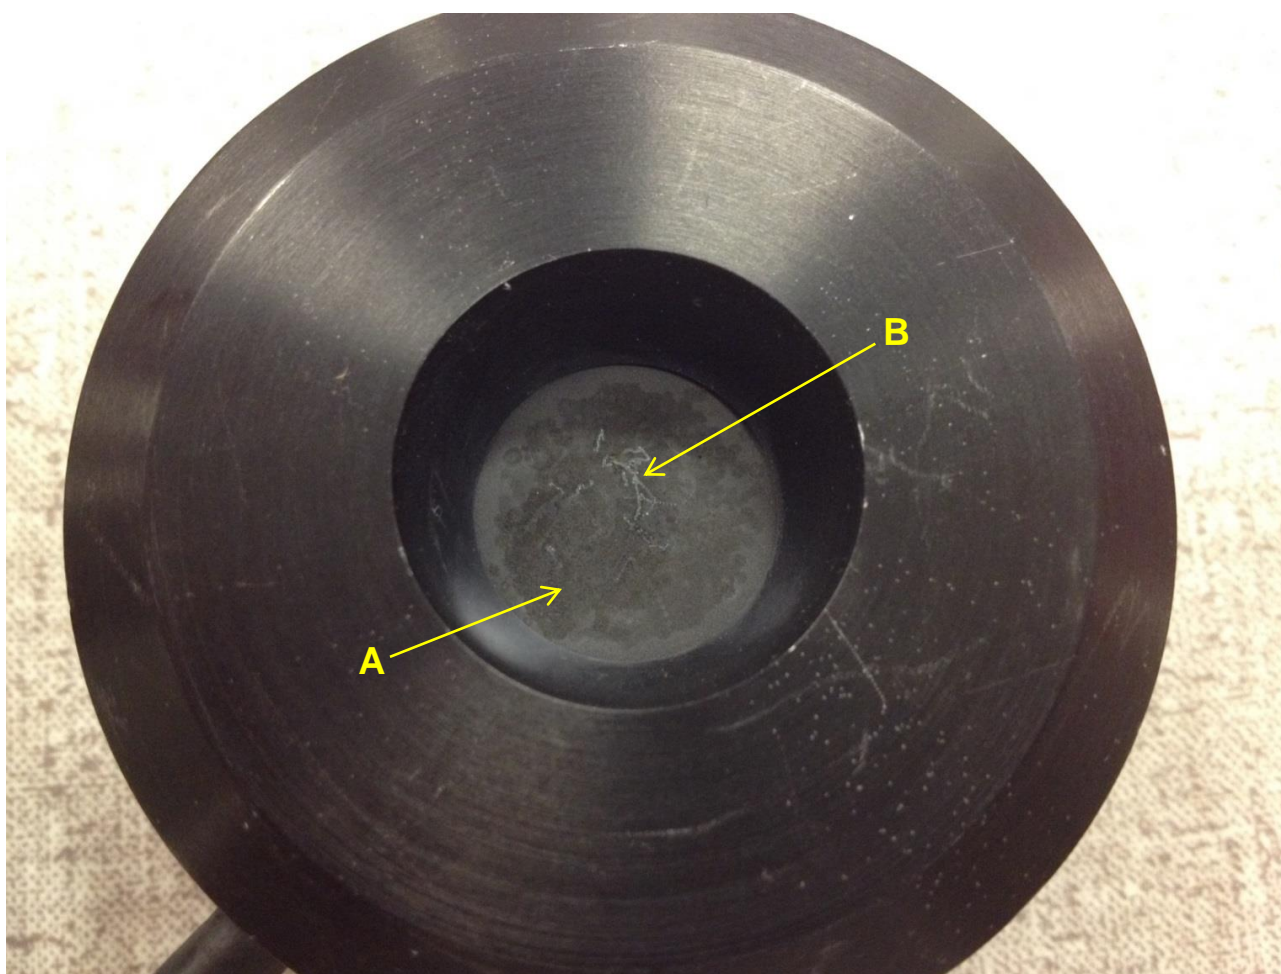
Figure 2: Discoloration and Scratches While Moving the Sensor during Measurement

- A. The dark discolorations that cover the entire sensor area are a collection of smaller circular marks caused by using a power density that is slightly higher than recommended while moving the beam around to different areas on the sensor disk.

Slight discolorations (either slightly lighter or slightly darker marks) should not cause sensor performance issues. However, the circular marks pictured above are darker than the flat gray color of a healthy sensor surface, which indicate that the coating is starting to burn. In this specific area, the damage has not ablated or melted the coating of the sensor. However, the dark discolorations indicate the coating is starting to burn. We recommend changing the absorbing disk before major damage is caused to the sensor.

- B. The marks that resemble squiggly scratches are areas where the coating has been ablated. This is the result of using a tightly focused beam and moving the sensor around in the beam path during a measurement. It is evident the coating is missing due to the exposed metallic color within the marks.

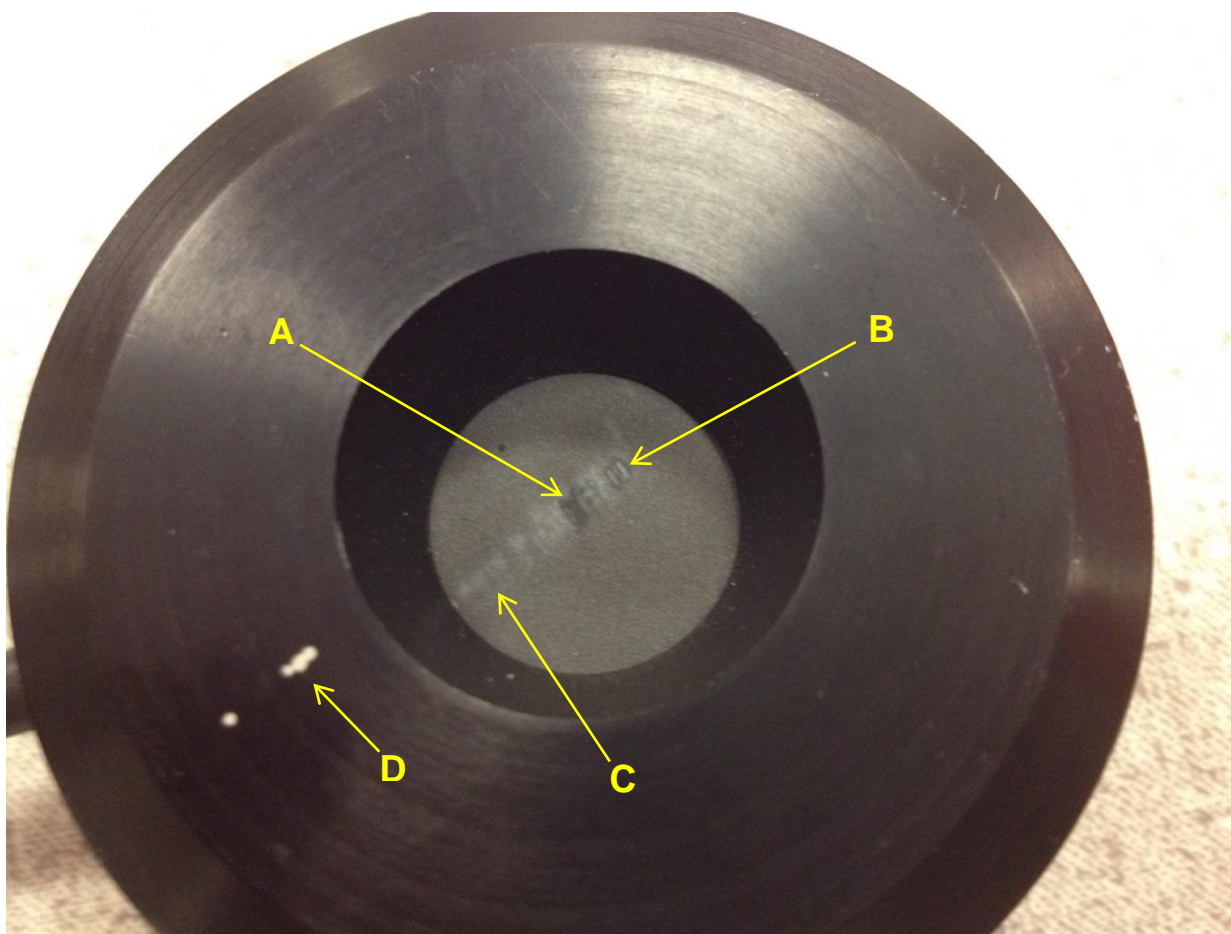
Figure 3: Thermopile near Its Damage Threshold While Moving Sensor during Measurement

- A. The dark marks indicate the coating is beginning to burn.
- B. Small metallic spots surrounded by a darker ring indicate the coating has been ablated

- C. The slightly lighter gray spots are on the boarder of what we consider damage. This is what happens if the sensor is used very near its damage threshold. The coating discoloration typically does not cause performance problems. If you continue to see similar discoloration or if the discoloration darkens, it is necessary to reevaluate the beam size before continued use. In this particular figure we recommend replacing the disk due to the presence of both dark spots and the ablated spots. The linear pattern of marks across this sensor surface appears to indicate that the sensor was moved through the beam path while the power density was fairly high.

- D. Ablation on the anodized housing of the sensor does not cause any performance problems with the product, but could be another indication that the power density is too high and that the sensor has most likely been placed too close to the focal point in the beam path.

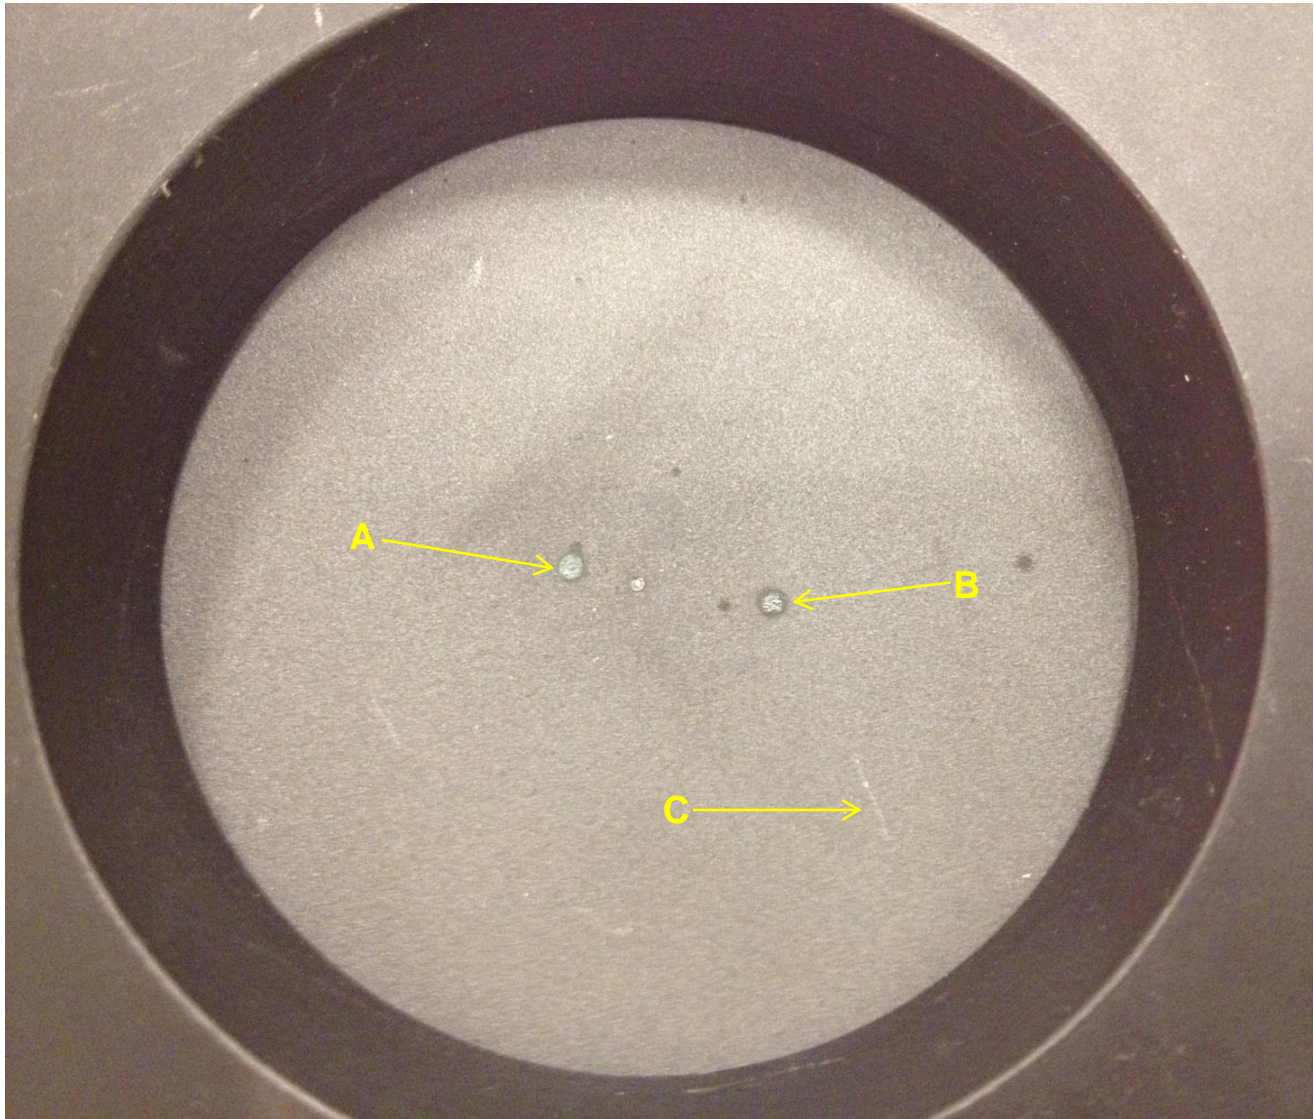
Figure 4: Thermopile Damage as the Result of Too High of a Power Density

This is a common example of what happens when too small of a beam size is used. The power density in these small circular spots has zapped the coating right off the sensor.

- A. The green color within the circular spot indicates that the sensor coating has started to melt at that spot. The presence of the color green on the sensor surface represents relatively significant damage due to a melted coating.
- B. Within this spot, metallic color is surrounded by a darker ring which means the coating has been ablated and there is charring around the ablation. This is caused by too high of a power density hitting the sensor surface. The sensor disk must be replaced in order to recalibrate it.

- C. Small scratches are caused by something coming in physical contact with the sensor surface. For example, a tool could have hit the sensor surface while being put away, or perhaps the connector on the sensor's cable accidentally rubbed across the sensor surface. These small scratches are usually on the very surface of the sensor and will not cause major problems unless metal can be seen within the scratches of the coating. Typically, no replacement of the thermopile disk is required unless there are a number of scratches and the scratches are deep enough to reveal metal.

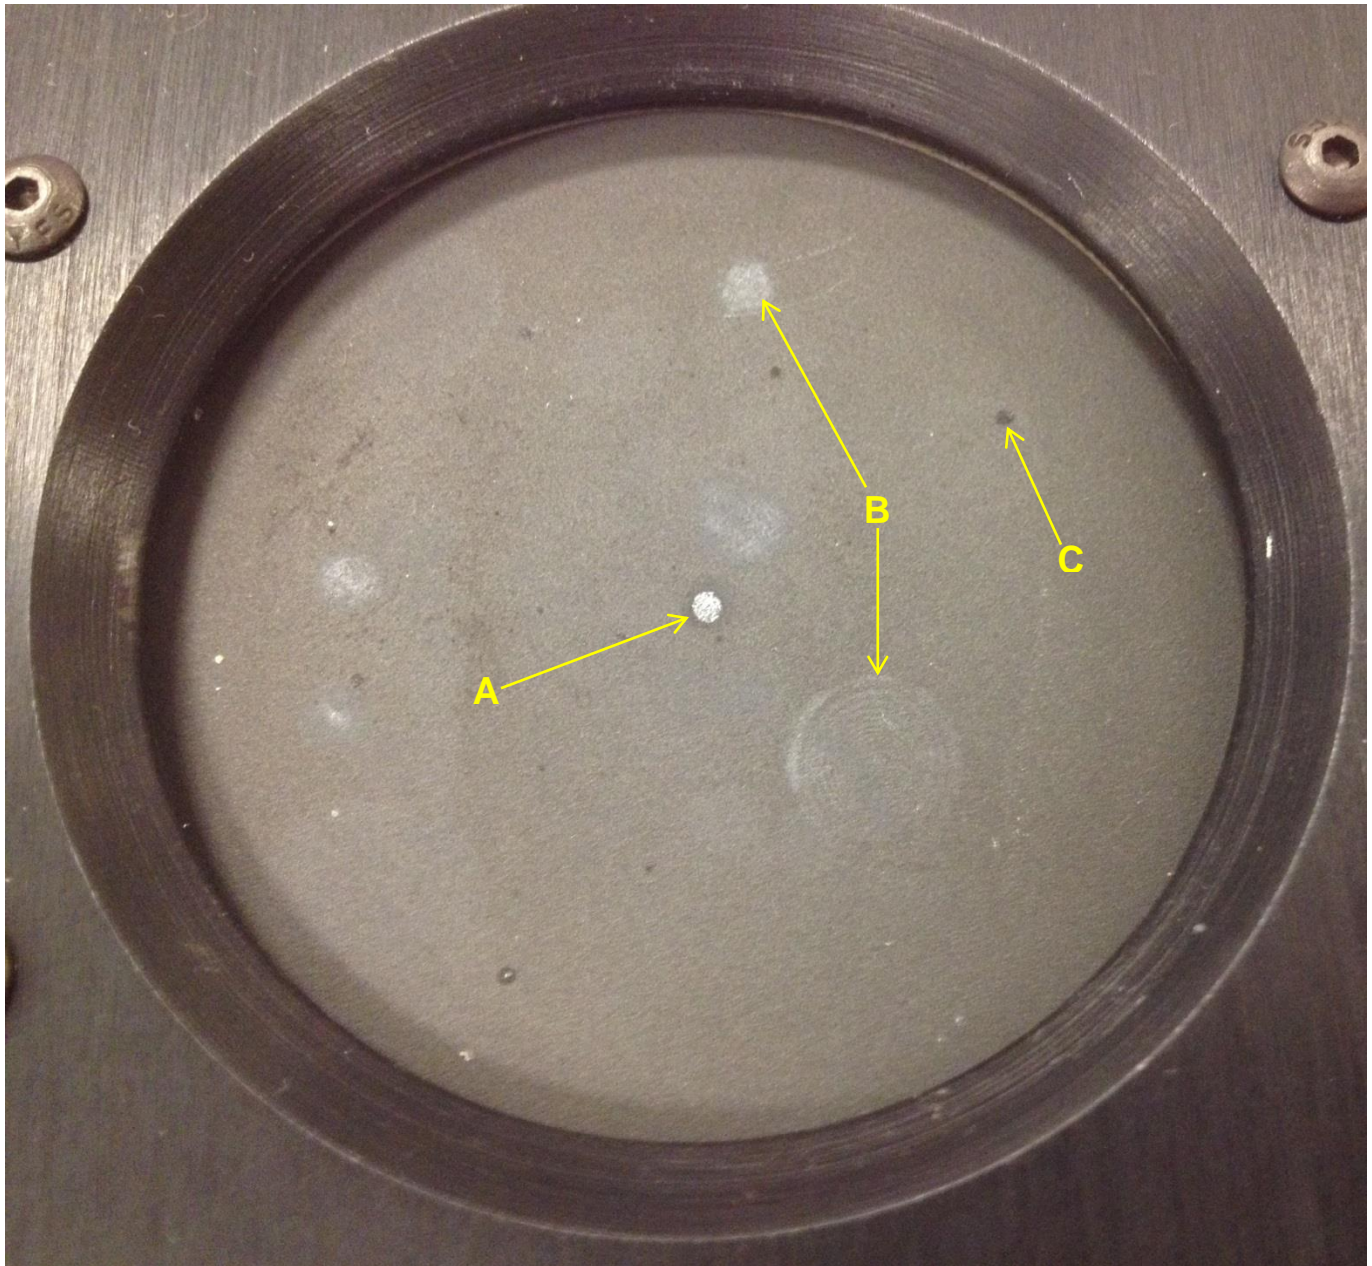
Figure 5: Severe Thermopile Damage Caused by Too High of a Power Density

- A. This is the most serious damaged spot within this figure caused by too high of a power density. The coating has been ablated and there is metal visible. The appearance of this spot would prompt a recommendation of replacing the sensor disk during repair or recalibration. Due to the spot's central location in this particular figure, the sensor cannot be recalibrated until the disk is replaced.

- B. There are a number of lighter colored marks on the sensor surface that appear to have been caused by a laser beam. These spots are slight discolorations in the coating and may or may not prompt a disk replacement depending on how many there are and their location on the sensor surface. Generally, if there are one or two slightly discolored spots like this, it will not greatly affect the sensor performance and the sensor can be recalibrated to account for any slight changes in absorption due to spots like these. If there are quite a few spots, to the point where the overall absorption of the sensor is compromised, it may prompt recommending a disk replacement.

- C. There are a few of these small black marks on this sensor which indicate some type of burn mark. It's possible a very small beam caused this type of burn. Or it could be that some piece of debris (maybe a piece of dirt or a drop of grease) landed on the sensor at some point. The next time a laser beam hit that spot, it may have burned the debris onto the sensor coating. Spots like this can burn in the laser beam even if the power density isn't real high. A few small spots like this on a sensor may not warrant replacing the disk. But larger spots or large collections of these spots could prompt replacing the disk.

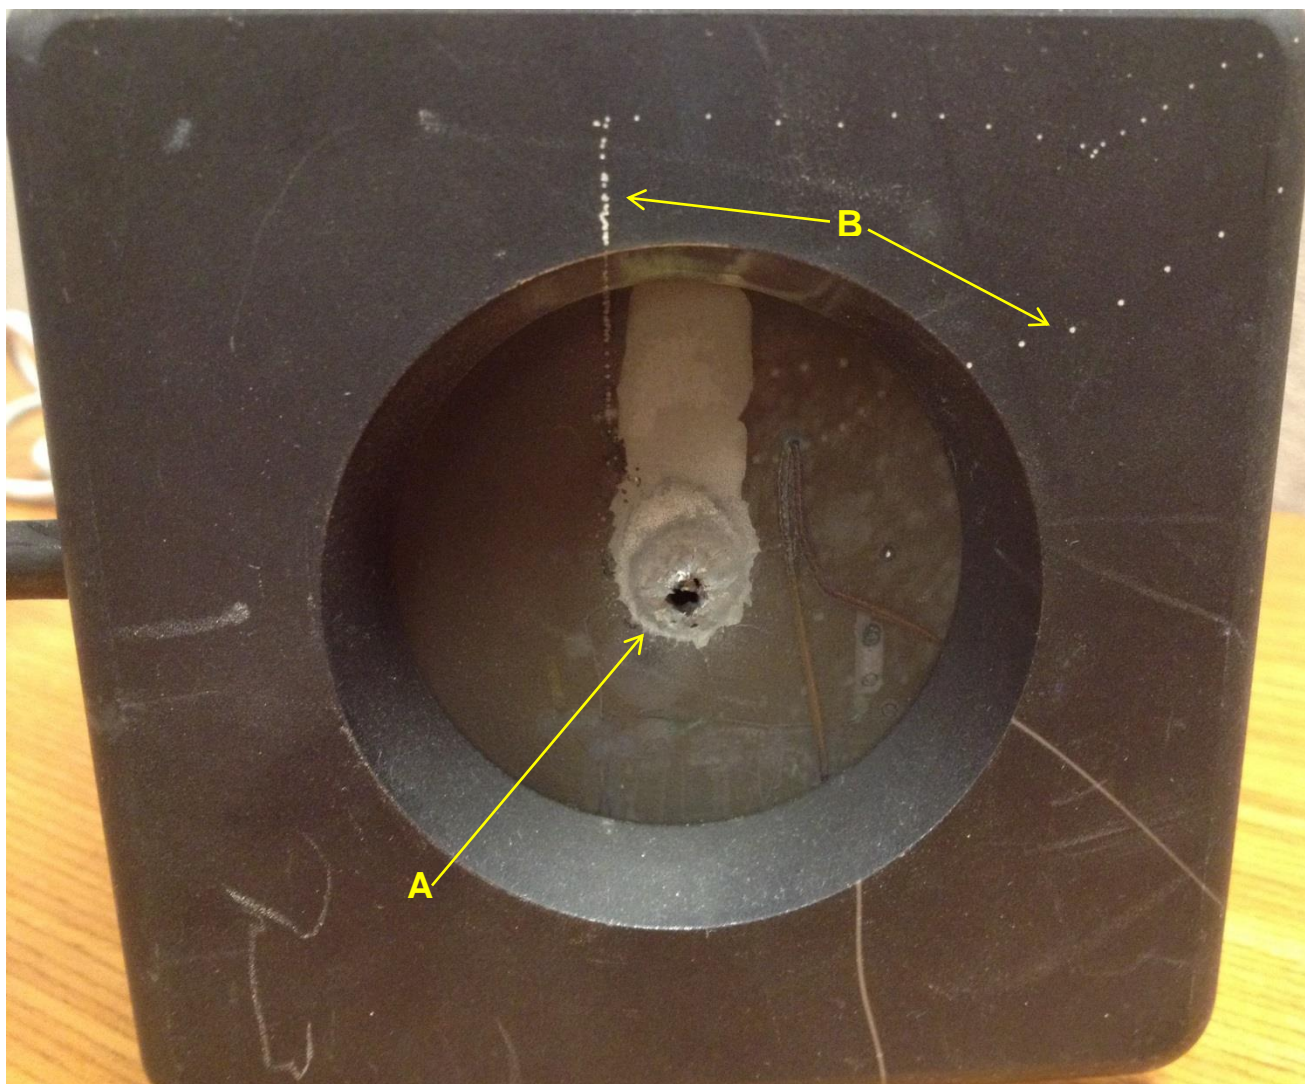
Figure 6: Very Severe Damage Caused by Too High of a Total Power Level and Density

- A. Example of a severely ablated and melted thermopile sensor rendered non-functional. The user most likely used too high of a total power level as well as too high of a power density, puncturing the middle of the sensor disk
- B. There are also a number of smaller marks around the housing and onto the sensor disk that would have been caused by a very tightly focused beam hitting the sensor. These marks did not cause the significant damage in the center of the sensor, but are a good indication that this sensor was not being used properly. These were most likely caused by a pulsed laser as the sensor was moved in and out of the beam path.

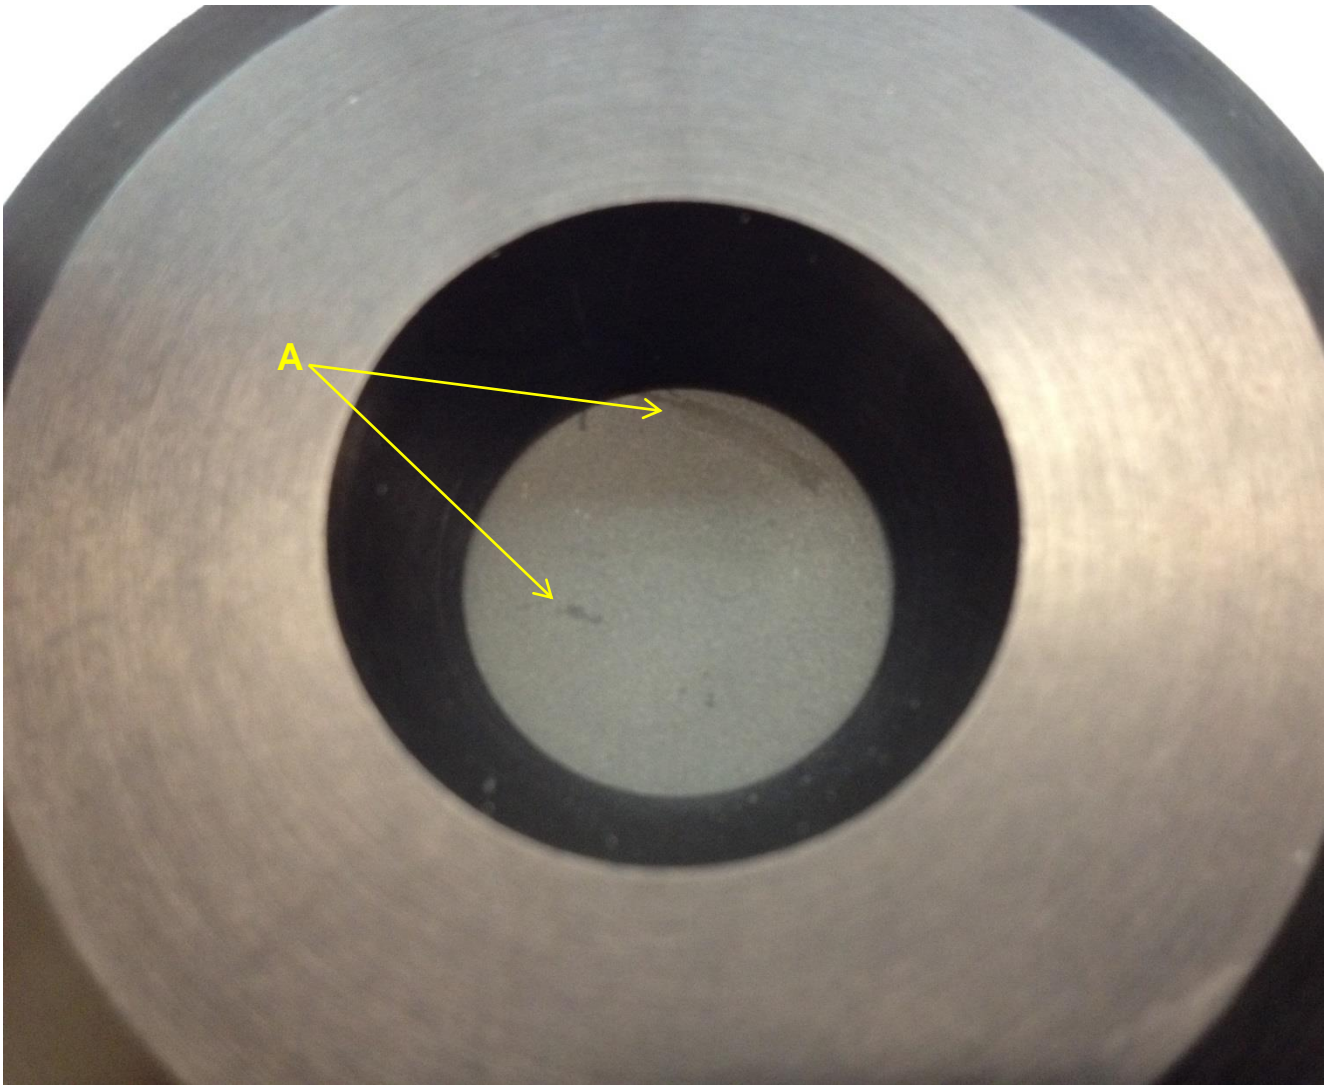
Figure 7: Streaks on Thermopile Caused by Contamination

This is an example of a sensor that has some marks on it that are most likely not affecting the performance of the product.

- A. The black streaks on this sensor surface were most likely caused by a small amount of grease or dirt that smeared across the sensor surface. Marks like this typically won't cause problems with a sensor, especially since they are not in the very center of the sensor area. There is a chance that marks can burn onto the sensor disk if a laser beam hits them. However, if the marks do not get larger or worse with time, a sensor in this condition will most likely continue to work properly and may not need a disk replacement during recalibration.

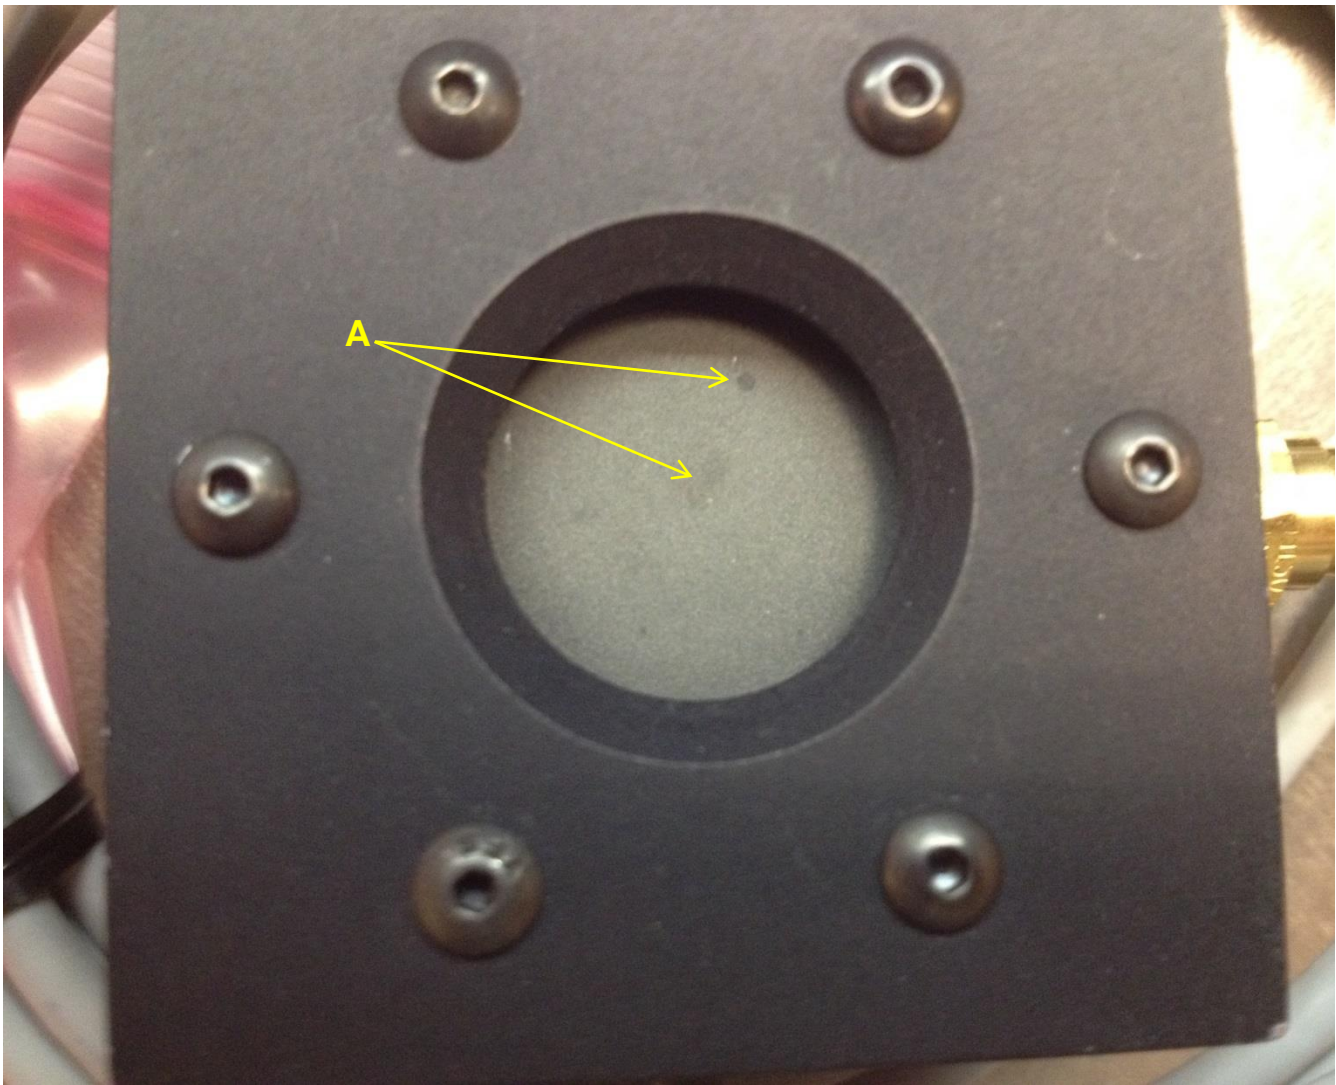
Figure 8: Discoloration Due to Contamination

- A. This is another case where there are some slight discolorations on the sensor surface most likely caused by small bits of contamination that got on the sensor disk. This type of discoloration is not severe enough to cause problems with the sensor's performance.

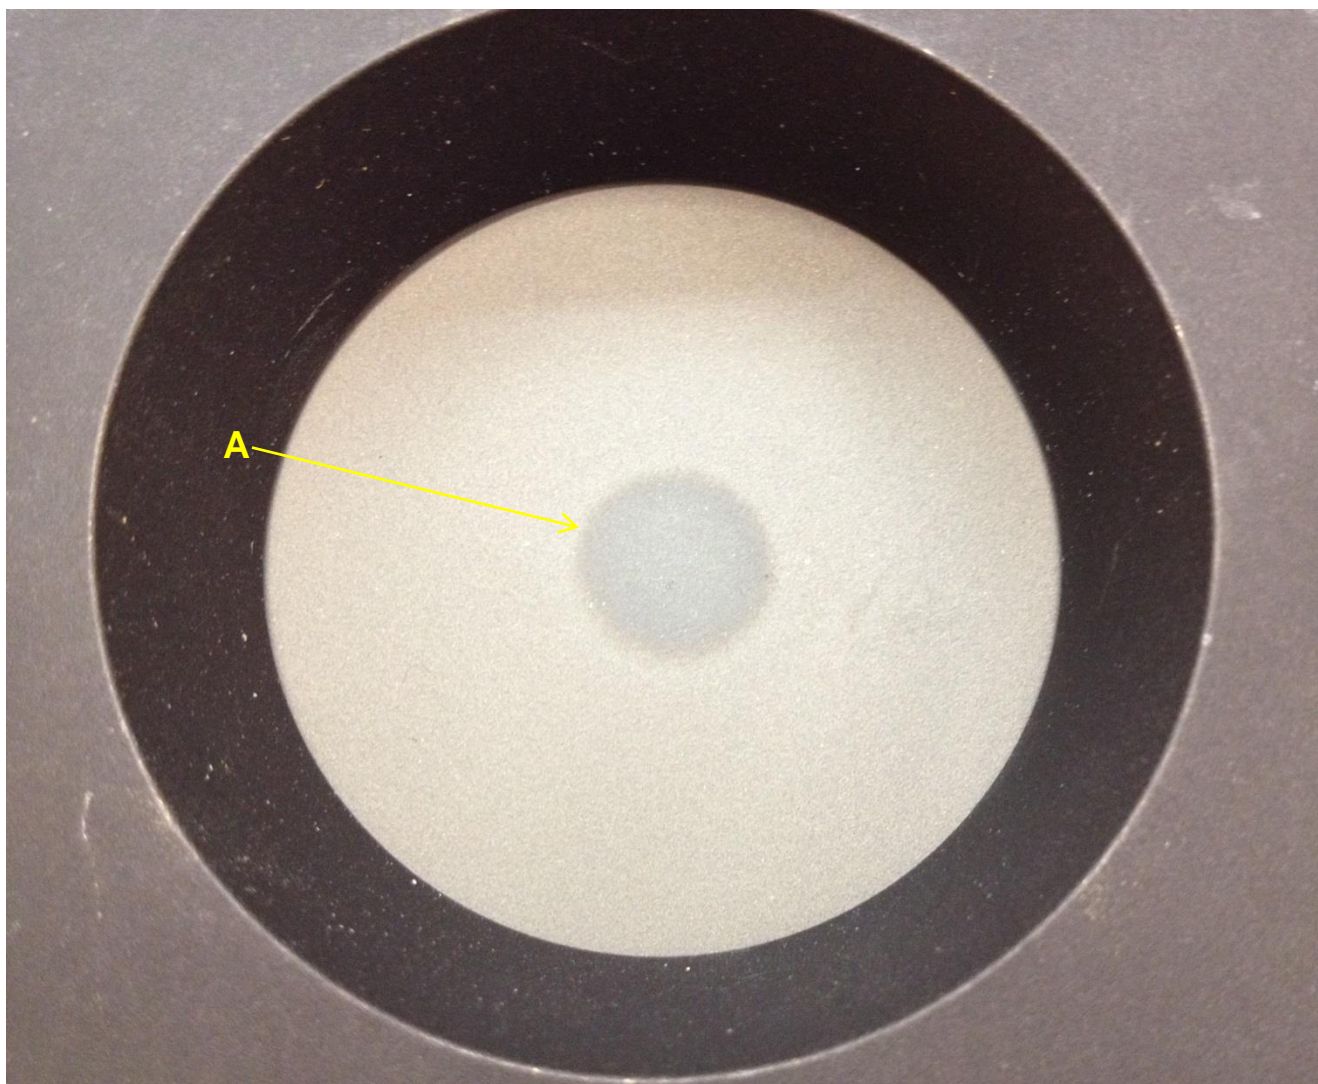
Figure 9: kW Level Power Sensor near Its Damage Threshold

This is a case specific to kW level power sensors such as the PM1K, PM5K and LM-5000 products.

- A. The discoloration in this area was definitely caused by a laser beam, although it is not to the point of melting, charring, or ablation yet. Some slight discoloration with the kW level sensors is somewhat normal just given the high amount of power that these sensors absorb. Therefore, a slightly lighter or darker spot similar to what is seen here isn't necessarily indicating that this has been damaged. This particular sensor technically has not been damaged yet. However, this discolored spot is starting to show a bit of a blue/green color to it, which means that the coating could be getting close to melting. If a spot like this shows up on the sensor, it would be recommended to take steps to reduce the power density that is being used on the sensor or to increase the water flow rate through the sensor to try and help keep it a bit cooler during measurements.

It is very important to understand the damage threshold and water-cooling requirements for kW sensor products. A water flow requirements note and kW damage threshold note have been created for these products, which should both be reviewed prior to using one of these kW level sensors. To learn more about water-cooling requirements for kW sensor products, read our [applications note](#).

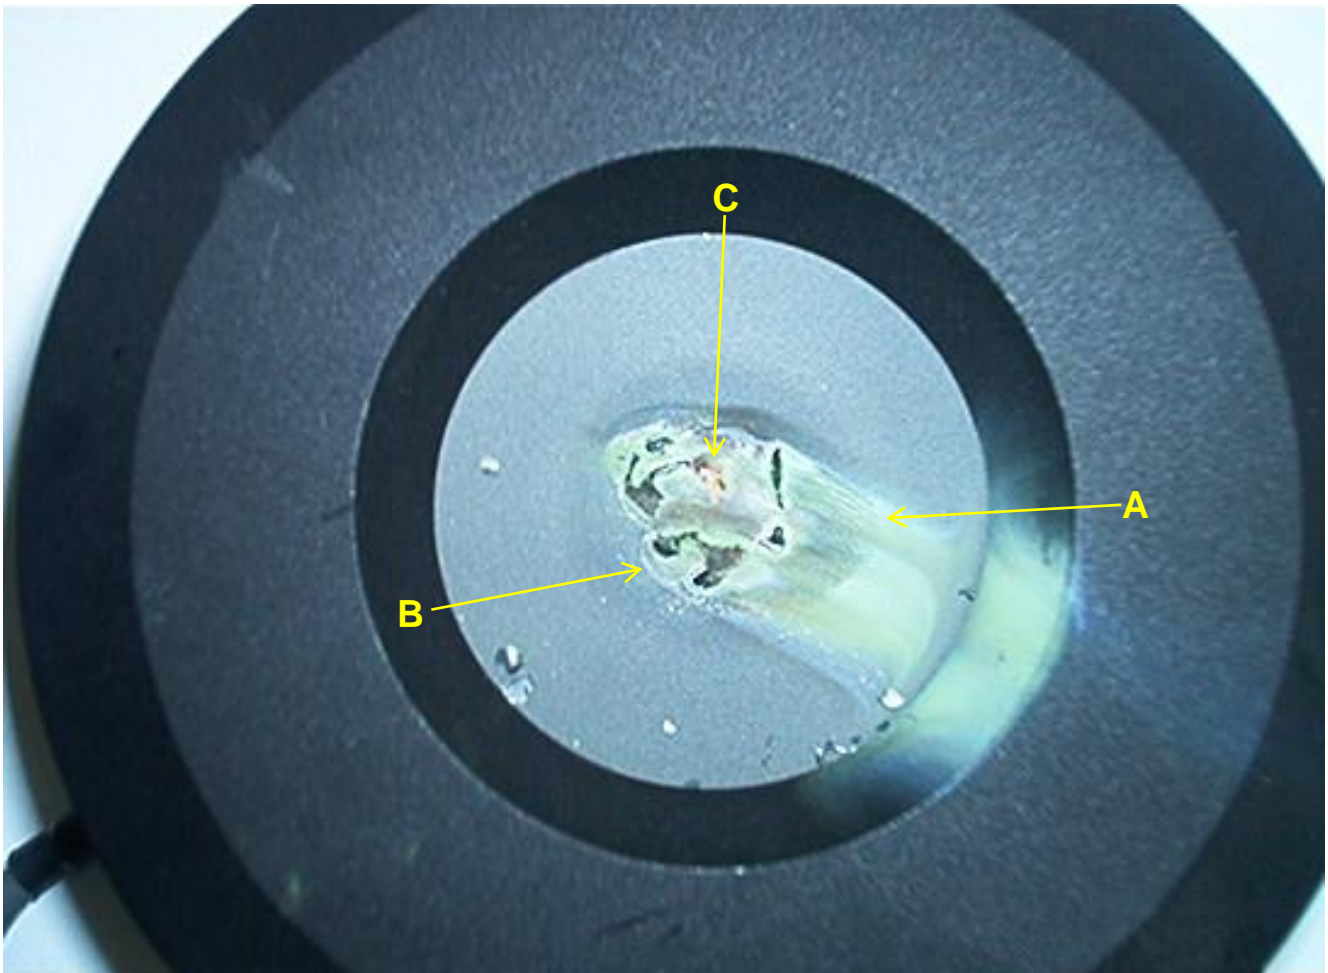
Figure 10: Significant Damage to kW Level Power Sensor Due to Too High of a Power Density or Insufficient Water-Cooling

- A. In this area a green color is present which indicates that the sensor coating has melted. In addition, there is green smoke in this damaged region.
- B. Black charring marks are present in this area.
- C. The copper thermopile disk is exposed near the center of the sensor

This sensor is an extreme case, but illustrates key things to watch for on the kW level sensors. Any time that a green melted spot, black charring, or exposed metal show up, the sensor has been significantly damaged and should not continue to be used in that condition. Damage like this can be the result of too high of a power density or from the sensor getting too hot, like what can happen without sufficient water-cooling.
